DEPARTMENT OF TRANSPORTATION**DIVISION OF ENGINEERING SERVICES**

Quality Assurance and Source Inspection

Contract #: 04-0120F4Cty: SF/ALA Rte: 80 PM: 13.2/13.9File #: 1.28**WELDING INSPECTION REPORT****Resident Engineer:** Pursell, Gary**Address:** 333 Burma Road**City:** Oakland, CA 94607**Report No:** WIR-013830**Date Inspected:** 05-May-2010**Project Name:** SAS Superstructure**OSM Arrival Time:** 700**Prime Contractor:** American Bridge/Fluor Enterprises, a JV**OSM Departure Time:** 1530**Contractor:** American Bridge/Fluor Enterprises, a JV**Location:** Job Site**CWI Name:** See Below**CWI Present:** Yes No**Inspected CWI report:** Yes No N/A**Rod Oven in Use:** Yes No N/A**Electrode to specification:** Yes No N/A**Weld Procedures Followed:** Yes No N/A**Qualified Welders:** Yes No N/A**Verified Joint Fit-up:** Yes No N/A**Approved Drawings:** Yes No N/A**Approved WPS:** Yes No N/A**Delayed / Cancelled:** Yes No N/A**Bridge No:** 34-0006**Component:** Orthotropic Box Girders (OBG)**Summary of Items Observed:**

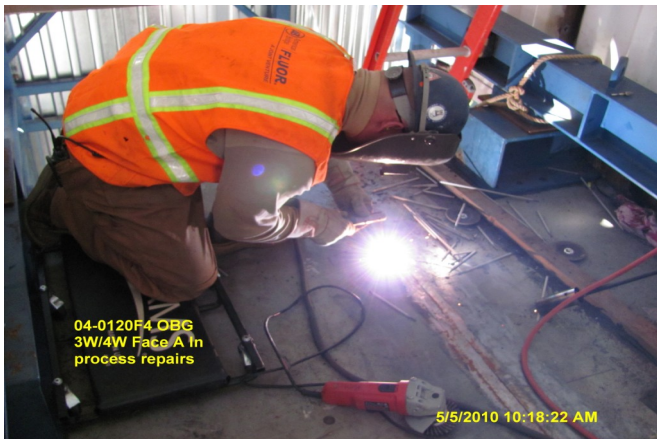
Field Splice 3W/4W Face A Repairs

The QA inspector periodically observed ABF welding personnel Jordan Hazalaar performing shielded metal arc welding (SMAW) for the rejectable indications previously identified by ultrasonic testing. QC inspector Tom Pascaulone was noted to be present in order to monitor the progressing and ensure the work was being performed in accordance with the welding procedure specification designated as ABF-WPS-D1.5-1001 Repair. The pre heat and interpass temperature was verified by the QC inspector to be with the WPS and the welding amperage was verified to be 185. The welder initiated the welding at Y locations designated 26,600mm, 26,800mm and 27,200mm after the QC inspector had performed a visual and MT review. The work for these locations were completed during the QA inspector's shift and appeared to be in general conformance with the contract documents.
